Collapsing Structures and Public Mismanagement

Wolfgang Seibel

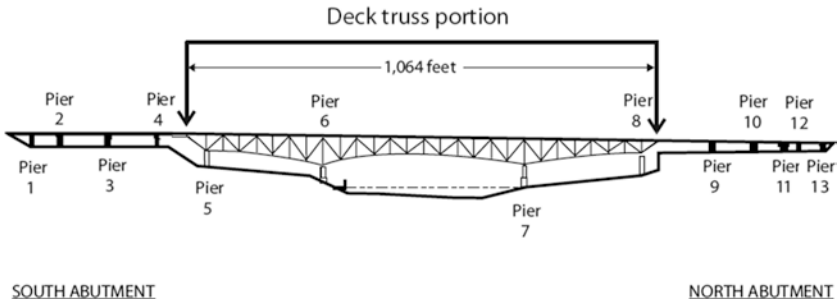
Illustration 3.3 I-35W Bridge, deck truss portion. (Source: NTSB Report, p. 7)

The immediate trigger of the disaster of 1 August 2007 were roadway works for which four of the eight travel lanes, two outside lanes northbound and two inside lanes southbound, were closed to traffic.

Subsequently, construction equipment and aggregates such as sand and gravel were positioned in the closed inside southbound lanes. These works were completed by about 2:30 PM. At about 6:05 PM, the bridge center span separated from the rest of the bridge and fell into the river.

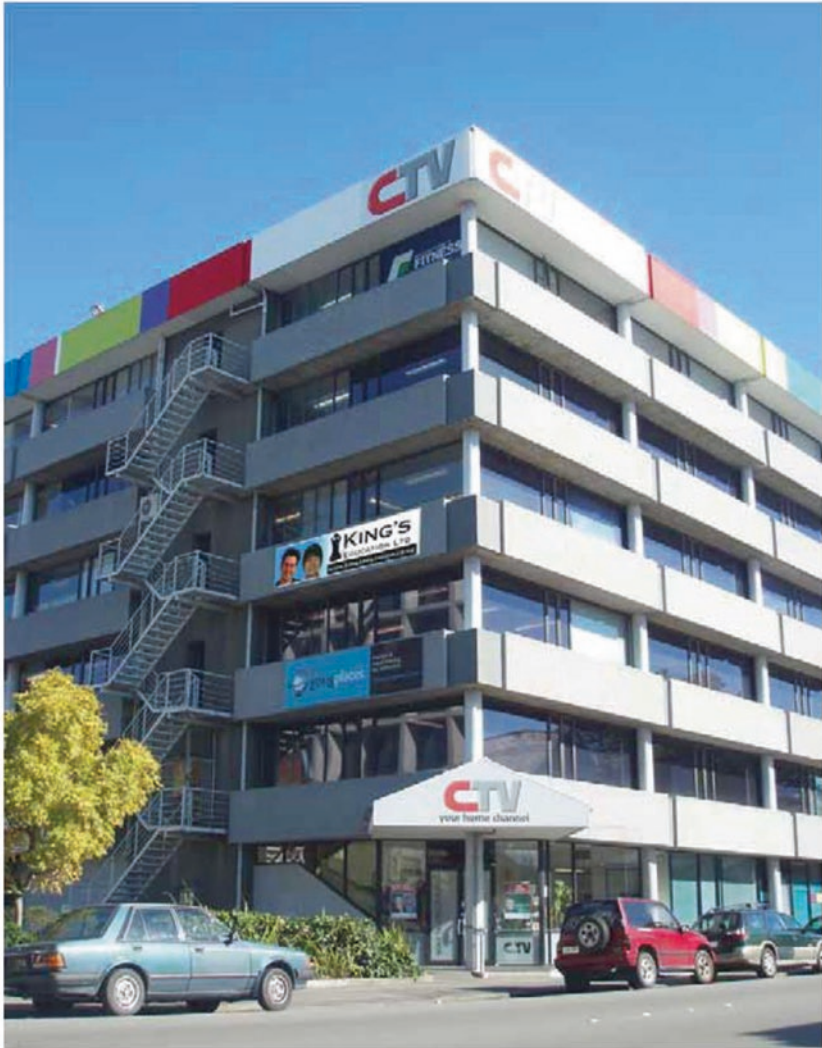
Illustration 4.1 CTV Building Christchurch prior to its collapse on 22 February 2011. (Source: Royal Commission Vol. 6, p. 3)

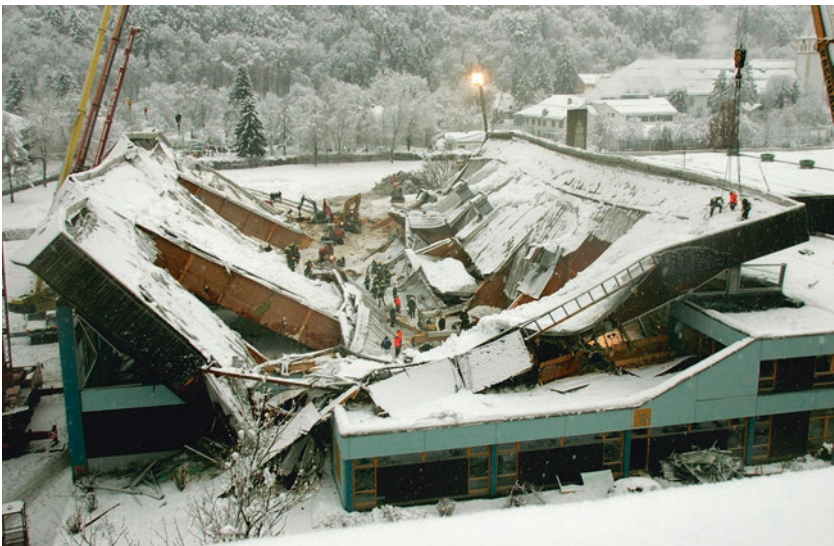
Illustration 5.1 Bad Reichenhall Ice Skating Rink after the collapse of 2 January 2006 (Deutsche Presseagentur / Picture Alliance, media no. 38145505, license 212103591)

The construction of the hall complex on behalf of the city of Bad Reichenhall began in 1971. The part of the hall that collapsed in 2006 was used as an ice skating rink in winter, otherwise as a tennis hall.¹¹ The hall went into operation in the Fall of 1973.¹² A subcontractor working on behalf of the general contractor was responsible for the planning, manufacture and erection of the roof construction.¹³ The subcontractor had delegated these works to a civil engineer for whom, according to his
